# **Institutional Safety and Quality Incidents & New Initiatives**

**NASA Safety Managers Meeting**

**3/20/2001**

**Safety Incidents/Mishaps at KSC  
FY 00 and 01**

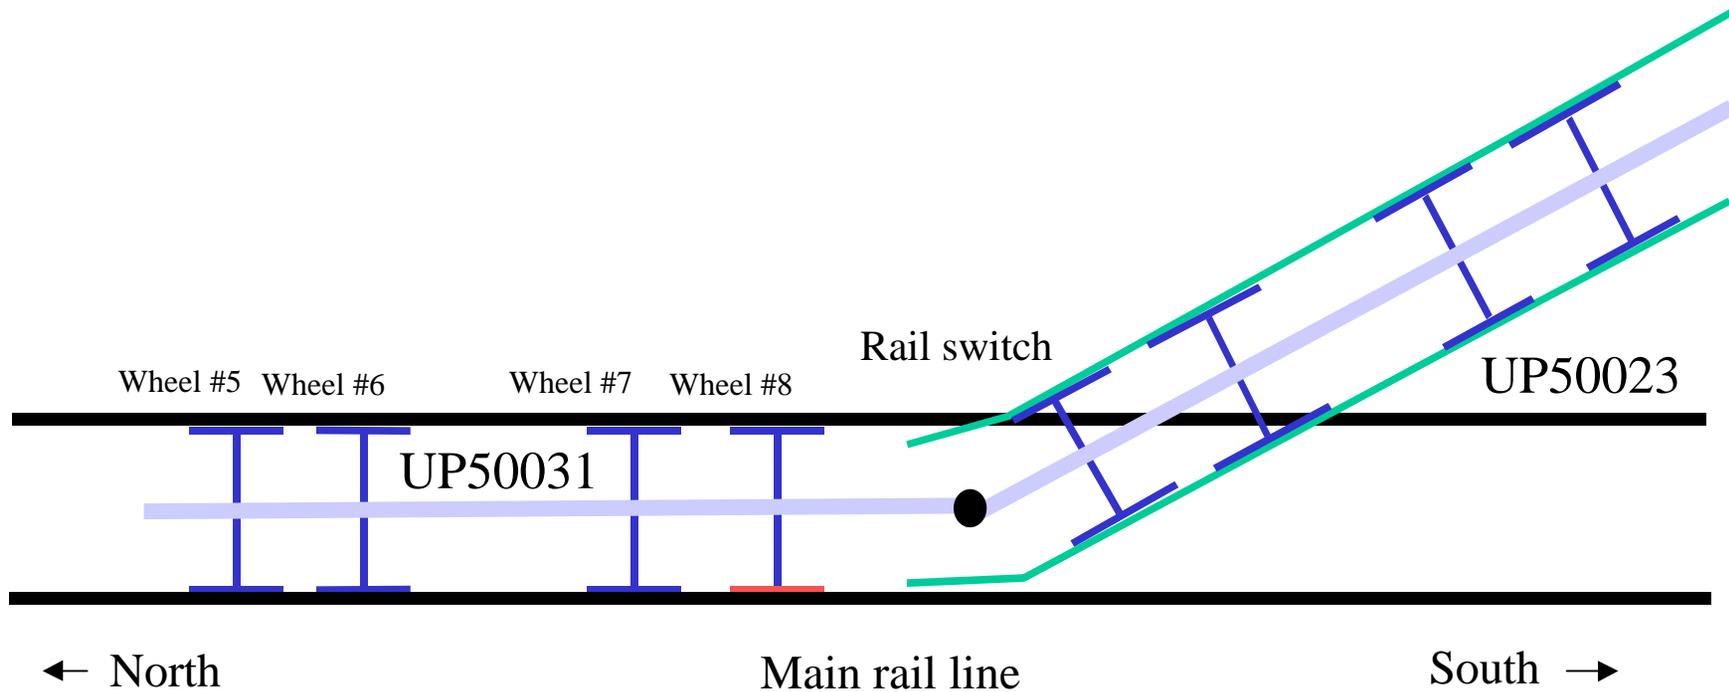
# RSRM-78 Incident    Discovery of Derailment

First two cars passed through rail switch

Rail Road siding South of Roberts Road Siding

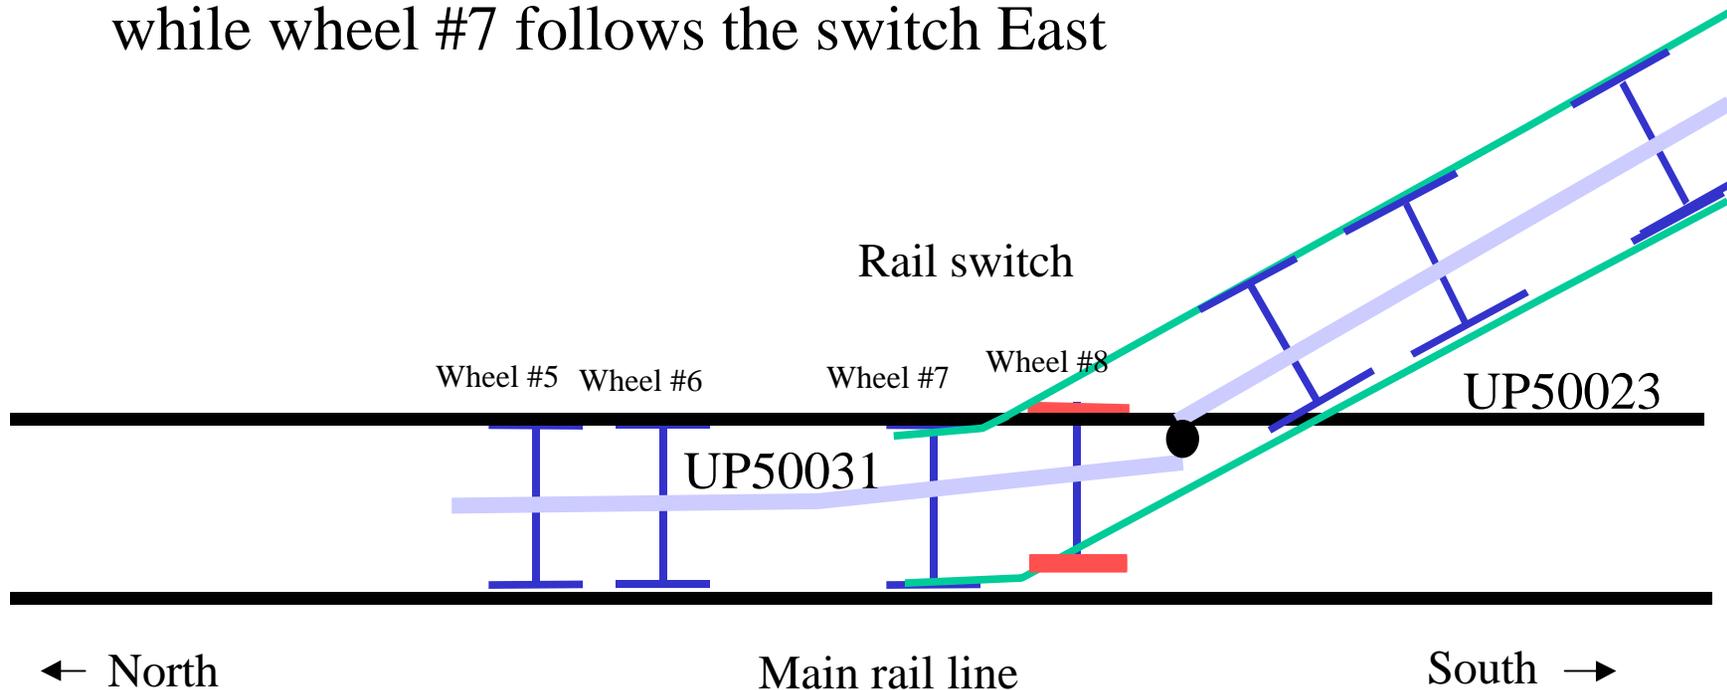
# RSRM-78 Incident    Discovery of Derailment

Wheel #8 continues South on main line  
while wheel #7 follows the switch East

Rail Road siding South of Roberts Road Siding

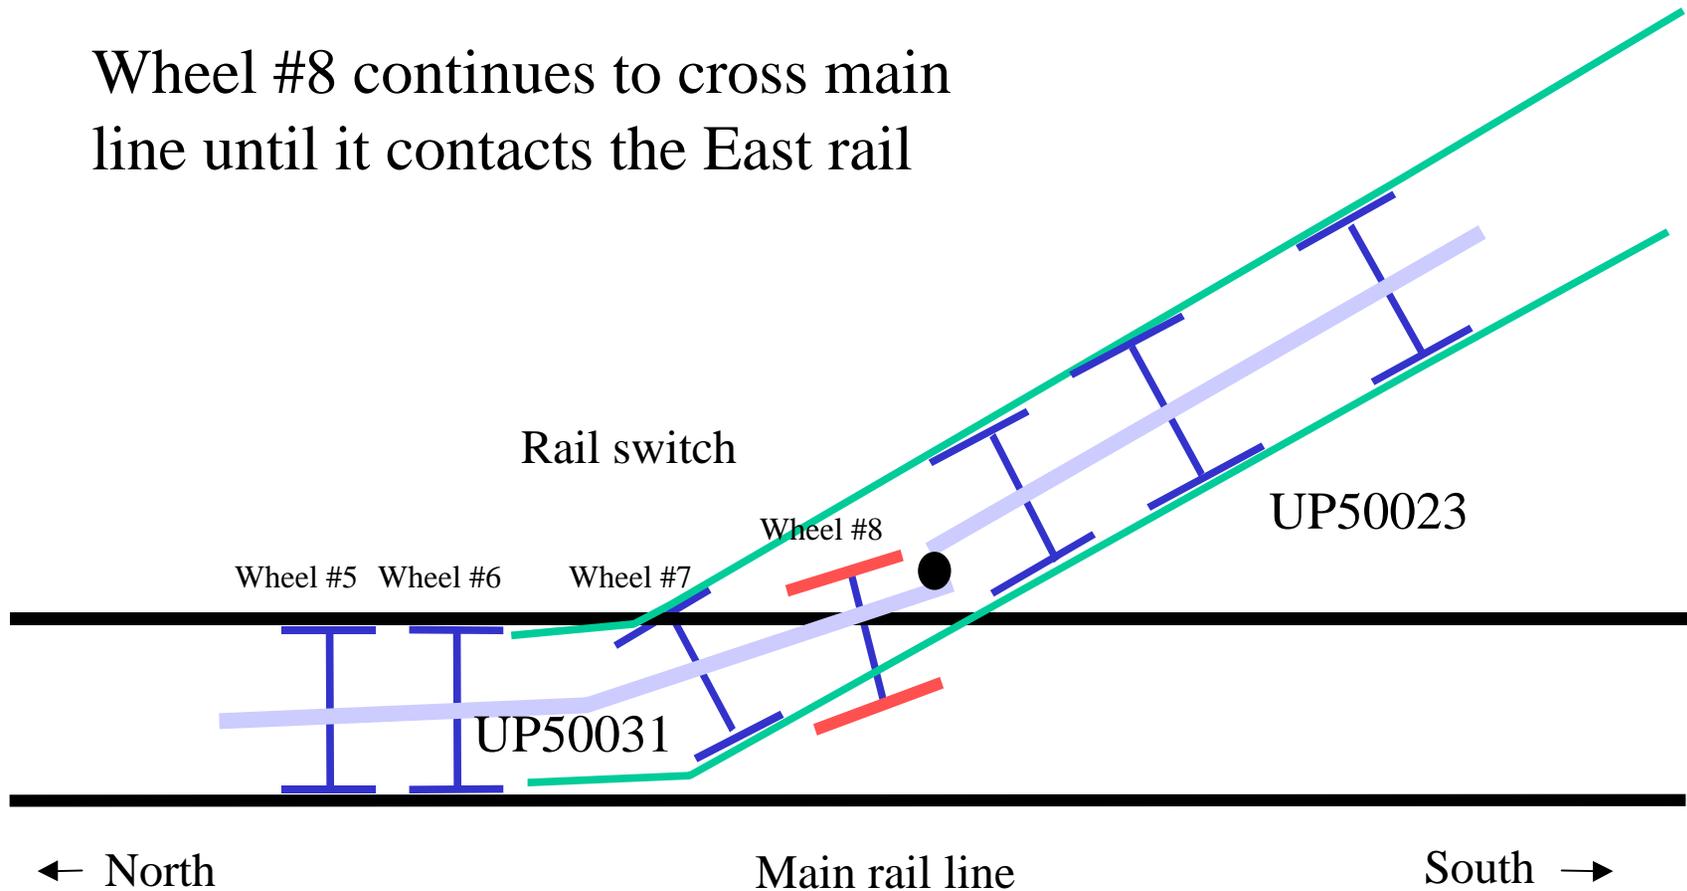
# RSRM-78 Incident Discovery of Derailment

Wheel #8 continues to cross main line until it contacts the East rail

Rail Road siding South of Roberts Road Siding

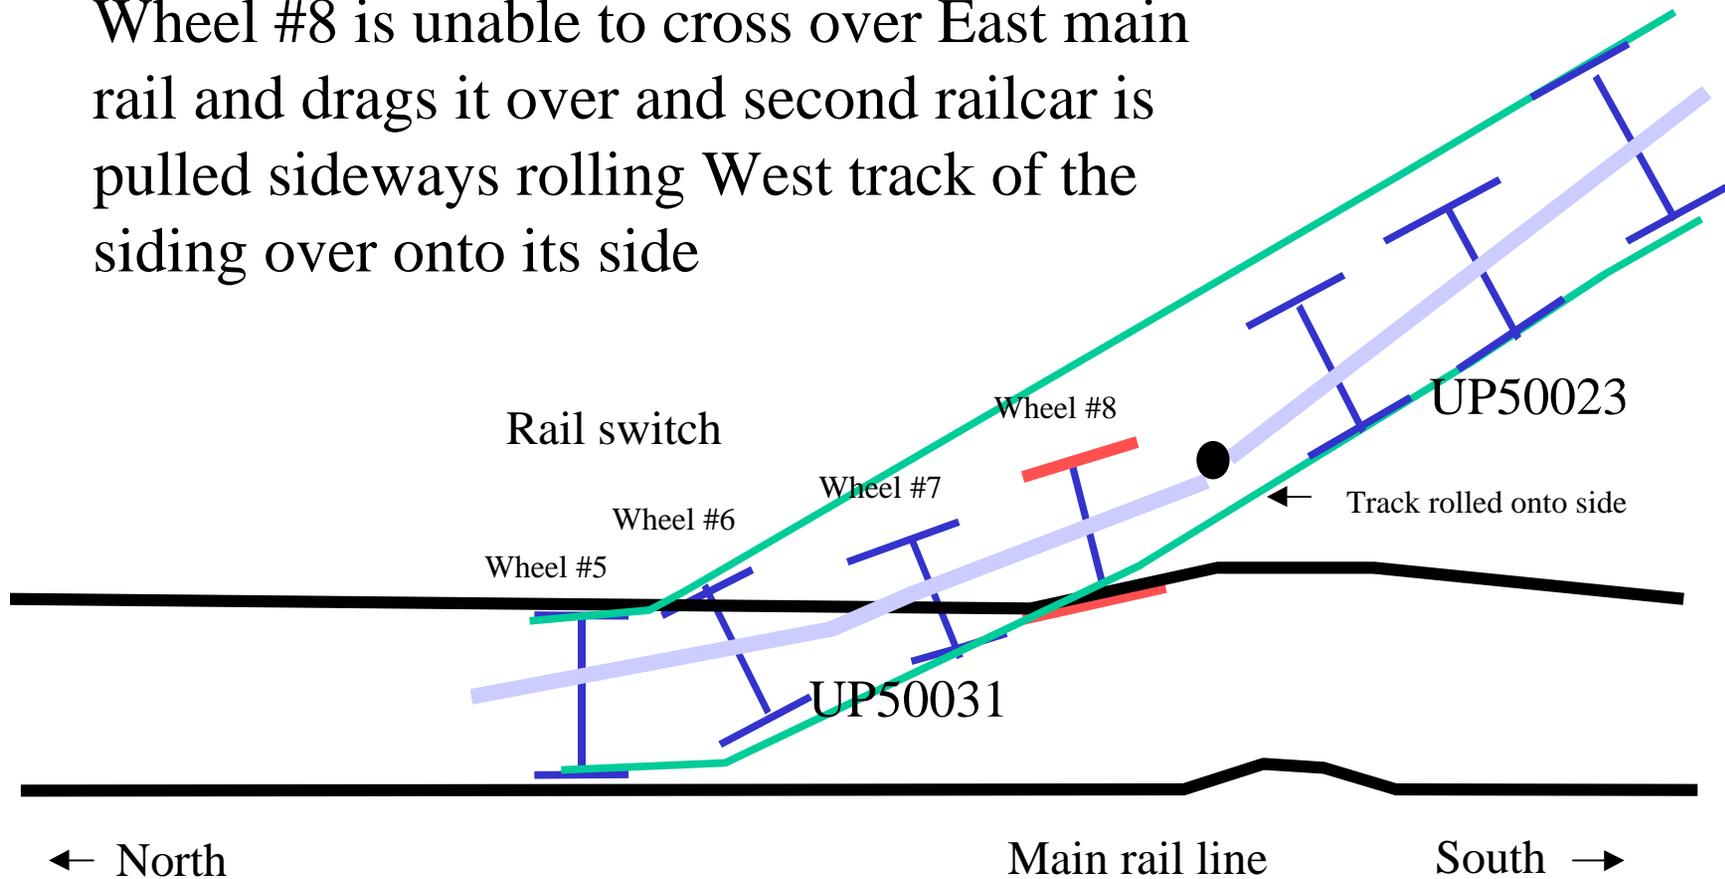
# RSRM-78 Incident    Discovery of Derailment

Wheel #8 is unable to cross over East main rail and drags it over and second railcar is pulled sideways rolling West track of the siding over onto its side

Rail Road siding South of Roberts Road Siding

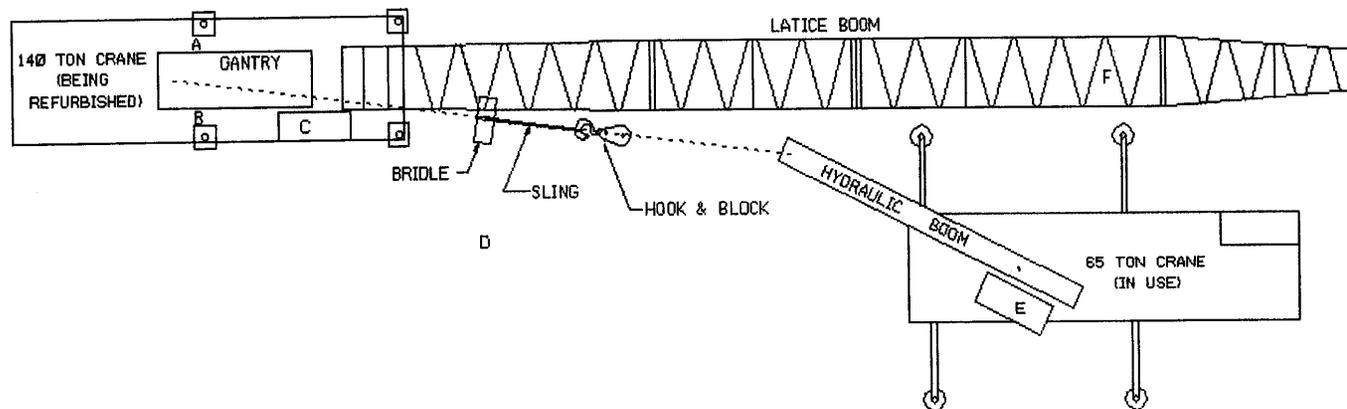
D-2

- A = RINGHAVER MECHANIC
- B = RINGHAVER MECHANIC
- C = SGS CRANE OPERATOR
- D = SGS FLAGMAN
- E = SGS CRANE OPERATOR
- F = RINGHAVER WELDER

Diagram of Mishap Scene

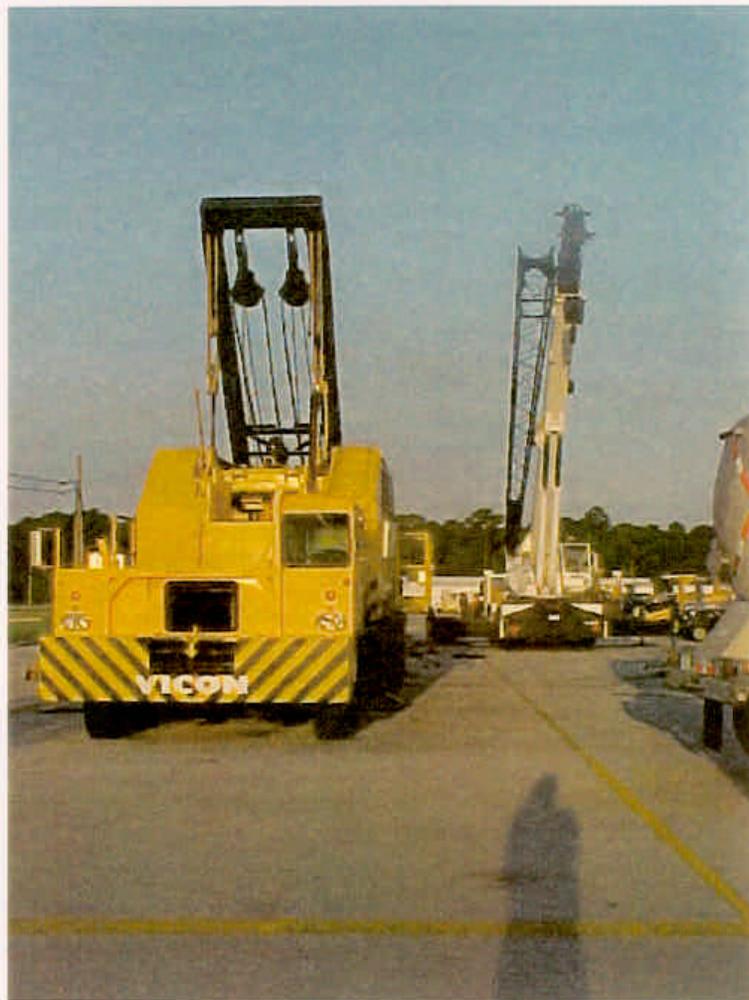
140-ton & 65-ton crane positioning

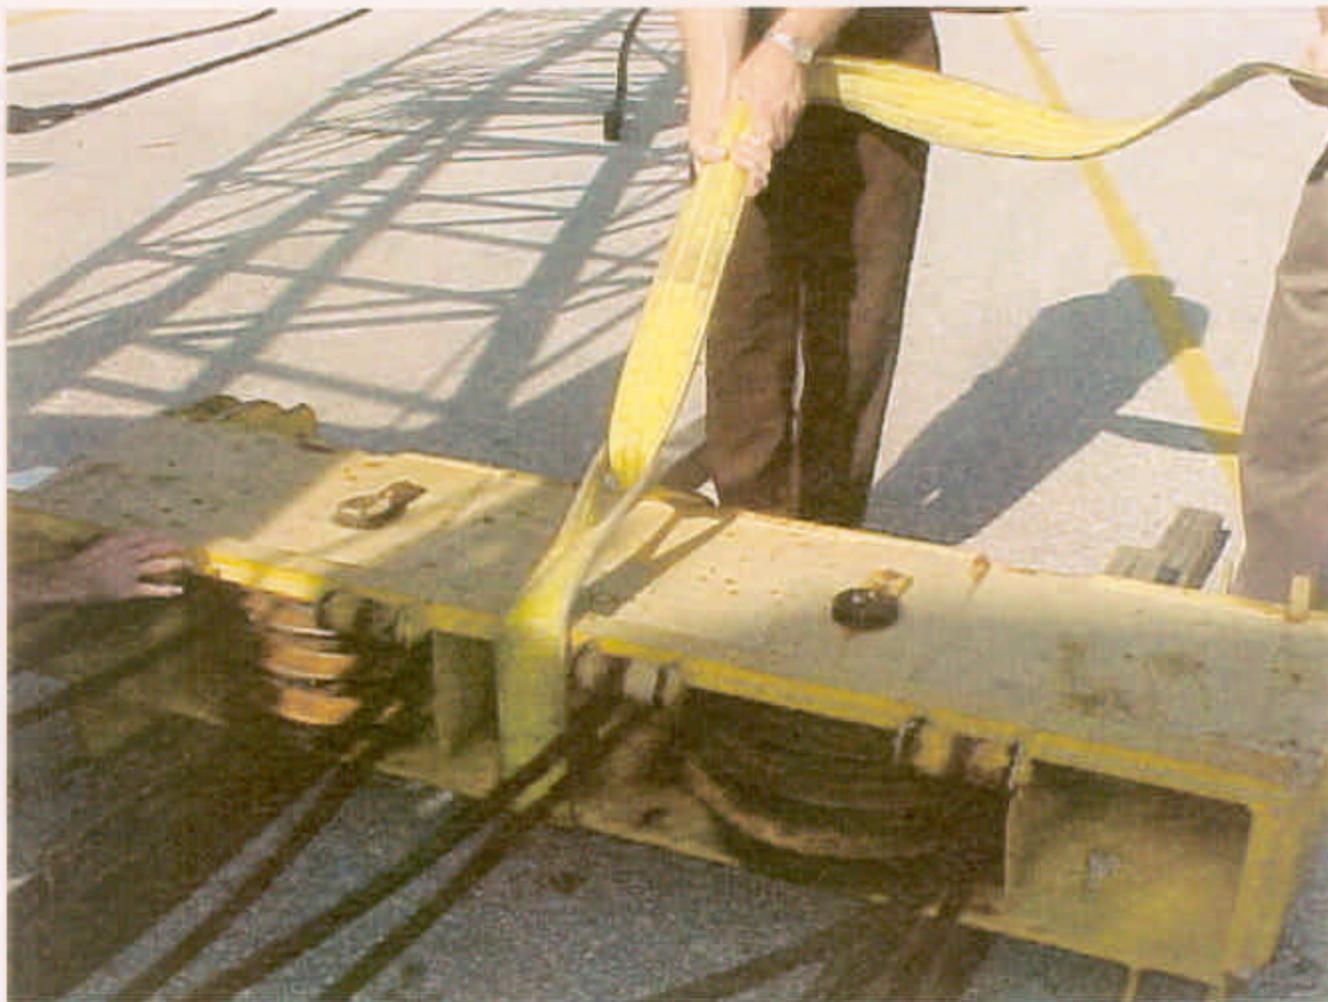
Re-enacted choker sling configuration on bridge

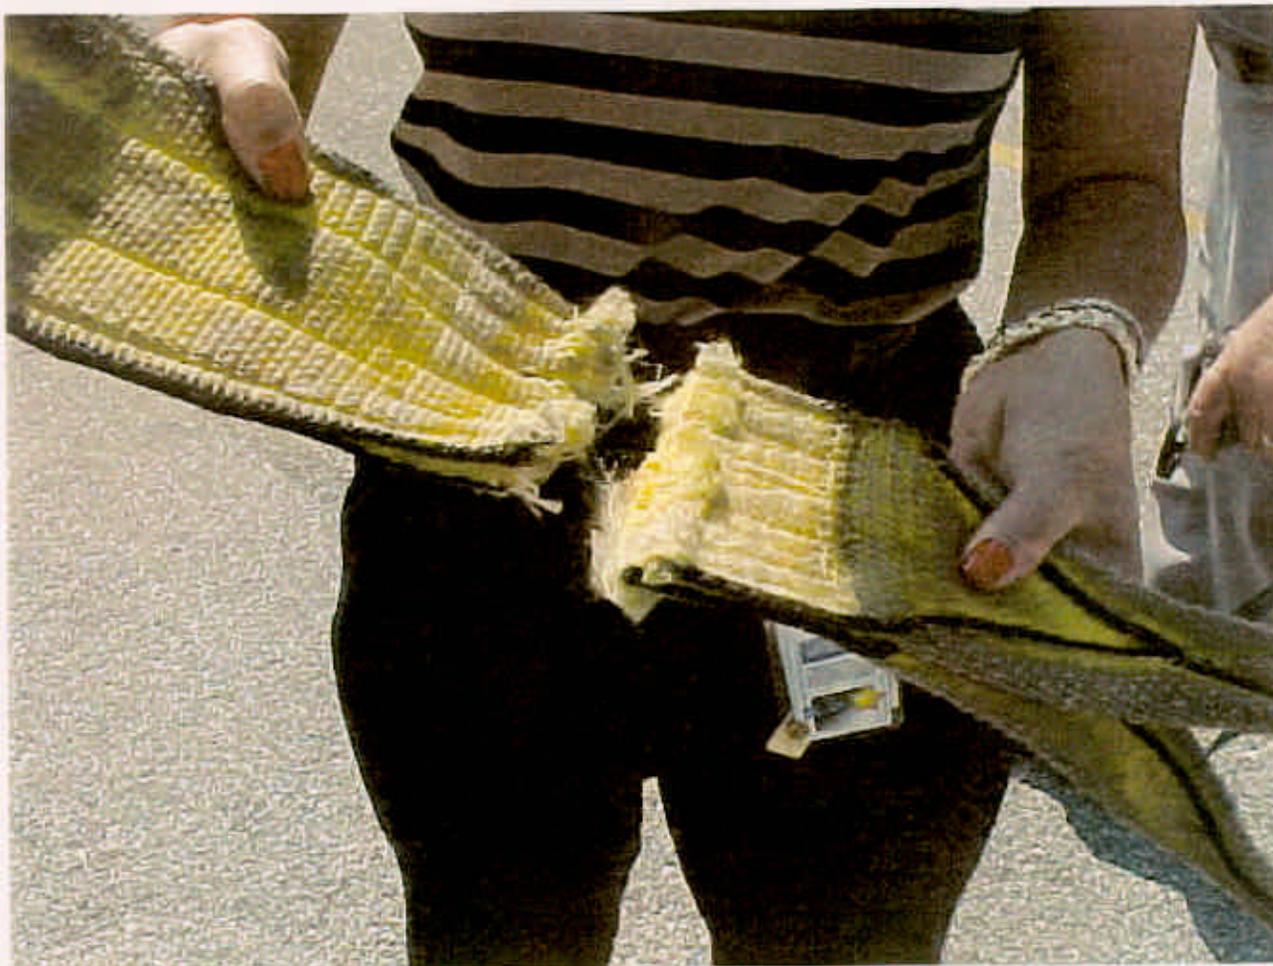
Failure area of sling

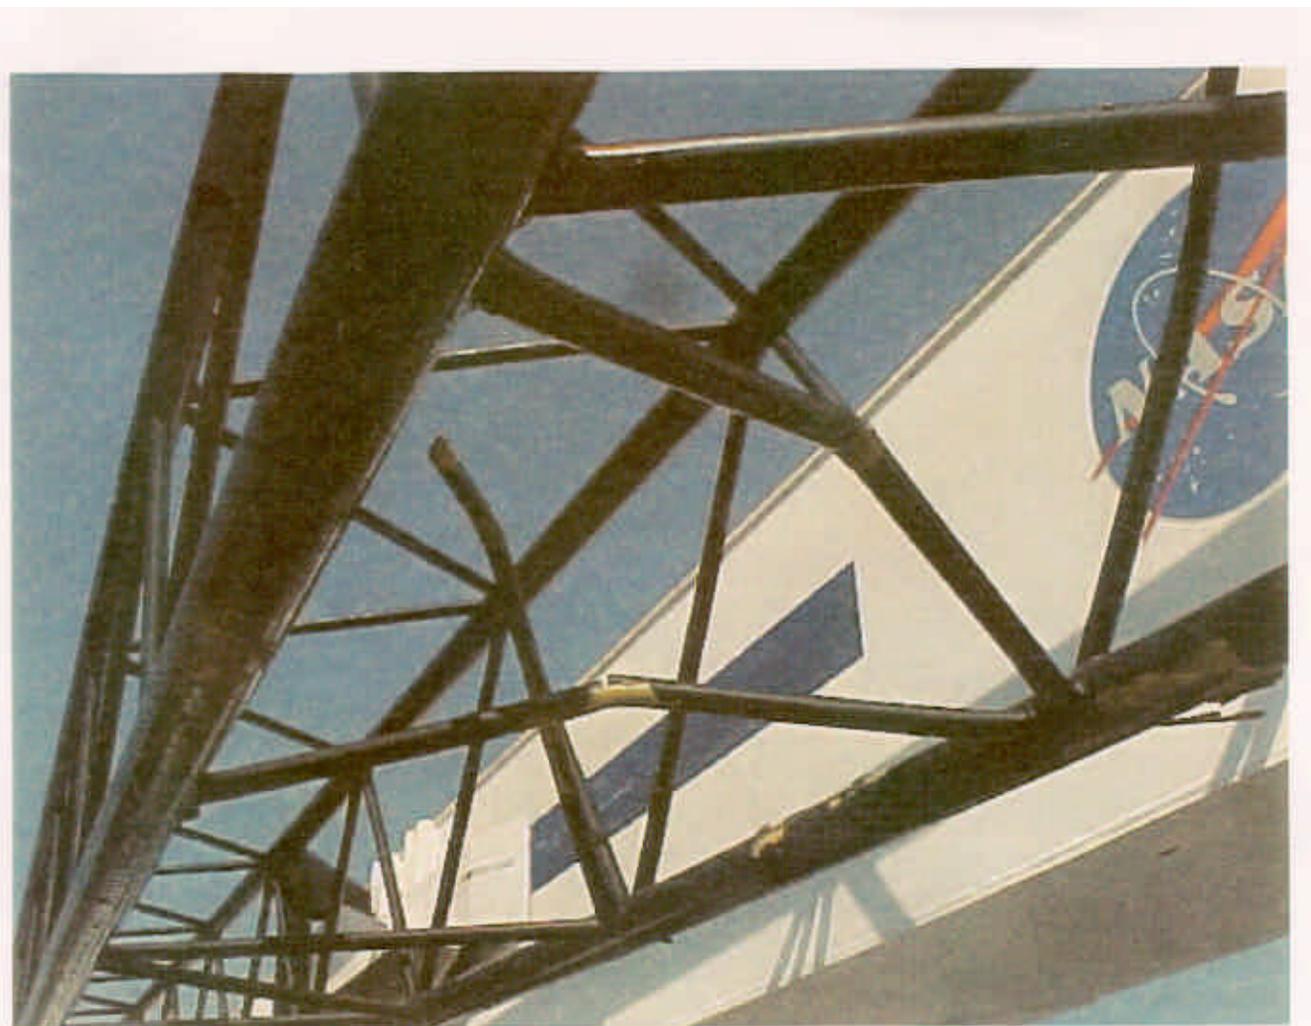
Damaged jib of 65-ton crane
